Community Opportunities Report

Prepared for:
Neuadd Aberdyfi

Prepared by:
Andy Rowland,
ecodyfi

Status:
Final
23/09/2015

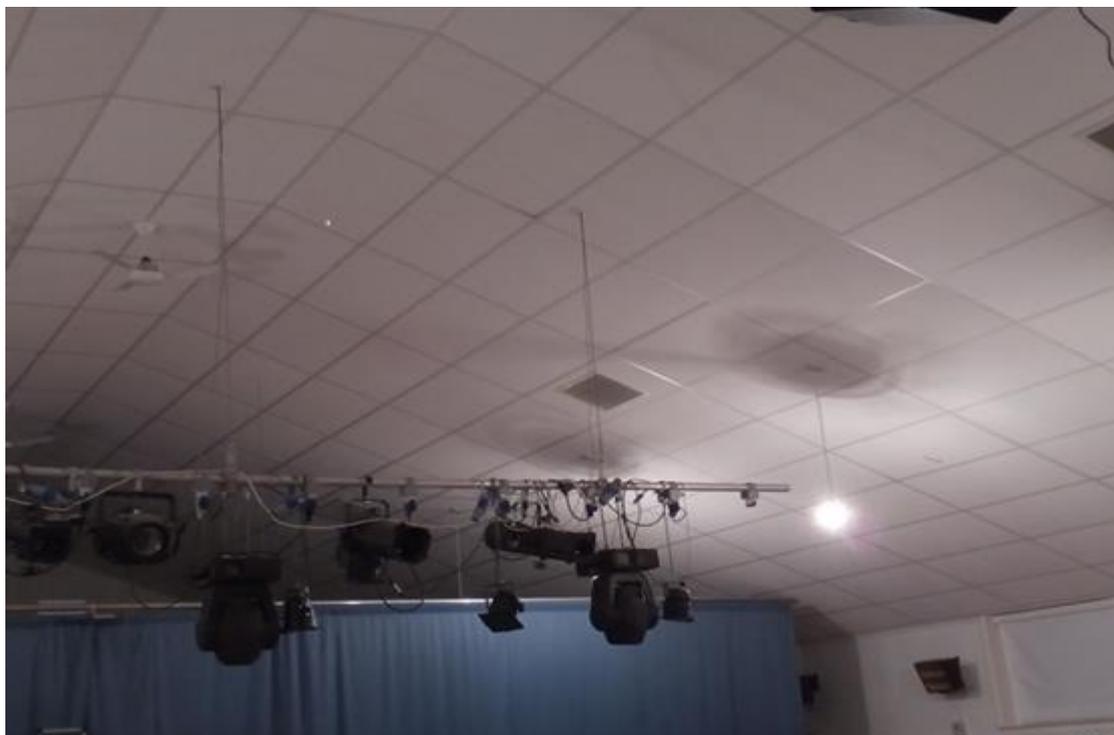
Picture 2: Ceiling above the dance floor area

Current situation:	The Annexe has an insulated ceiling but the Hall ceiling is profiled steel insulated to approximately 0.4u . Above the stage area there is no suspended ceiling
Recommendation:	Consider insulating the Hall ceiling
Appendix:	2.1.2

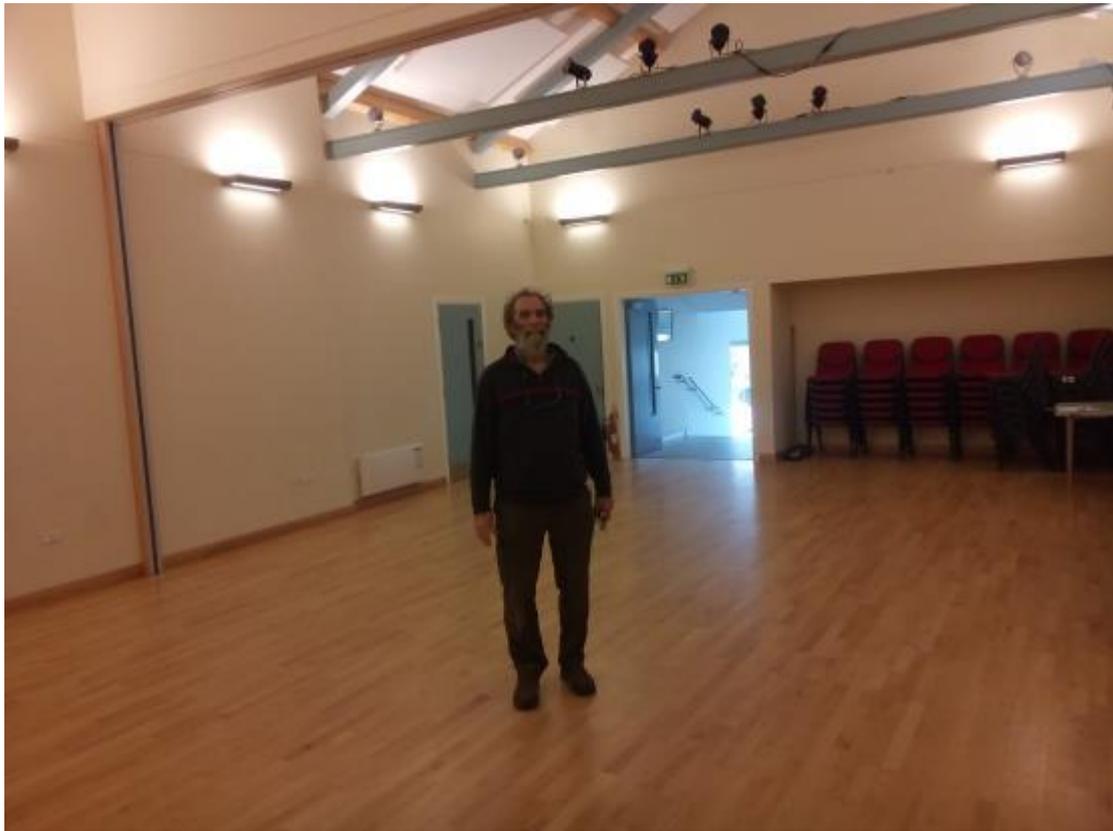
Picture 3: Studio

Current situation:	<p>This was the main reason for the survey, as the studio has inadequate ventilation for high usage situations. There are no windows and the roof has PV on it, with a sound-panel ceiling. The original design for three fans is considered unworkable by the managers, and a standard design of an extractor fan drawing cold air onto people from an inlet in each half of the room is not desirable. They have a design for a system that warms the incoming air by recovering heat from the out-going air, and also uses spare heat from the Ground Source Heat Pump to warm it further. The £37,000 estimated cost is a daunting fund-raising target, and the managers would like either an alternative solution or reassurance that this is the most appropriate design. Fan noise needs to be minimised.</p> <p>Ventilation in the Hall is adequate but does not provide comfort. There are two large extractor fans at the road end, drawing cold air in through two large ducts from the opposite (sea-facing) end.</p>

Recommendation:	A heating and ventilation survey for the whole building; a design for ventilating the studio and consideration of a Ground to Air Heat Pump for the Hall.
Appendix:	2.4.5
